# Damage Mechanisms Affecting Fixed Equipment in the Refining Industry

API RECOMMENDED PRACTICE 571  
SECOND EDITION, APRIL 2011

**Downstream Segment**

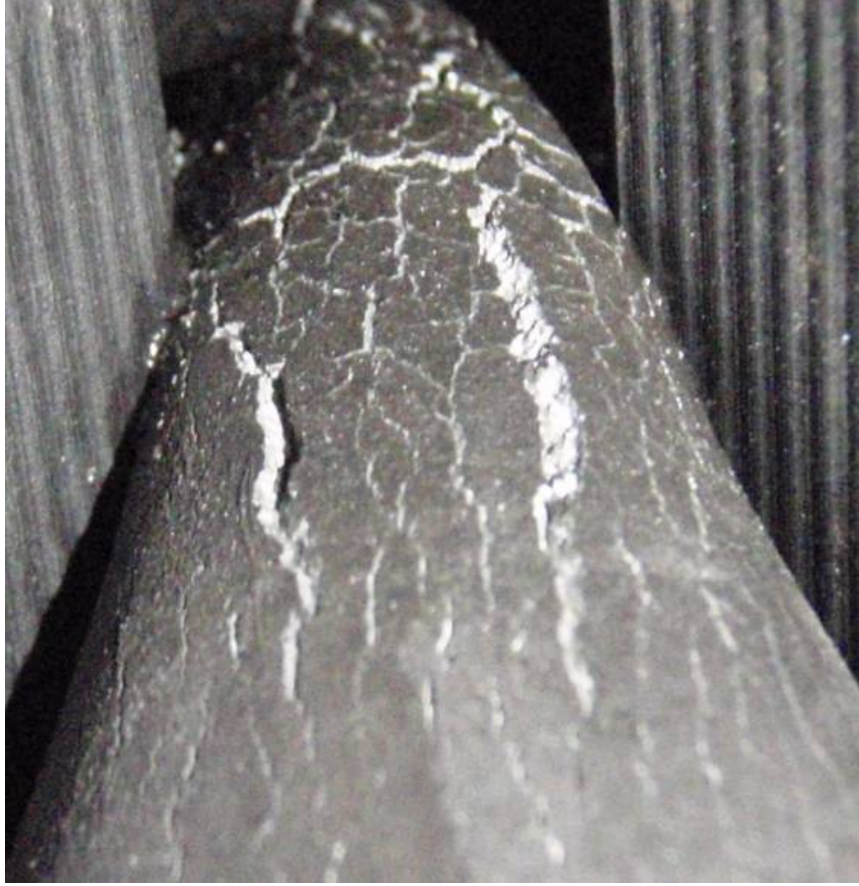
**Figure 4-17 – Pinched Alloy 800H pigtail opened up creep fissures on the surface.**

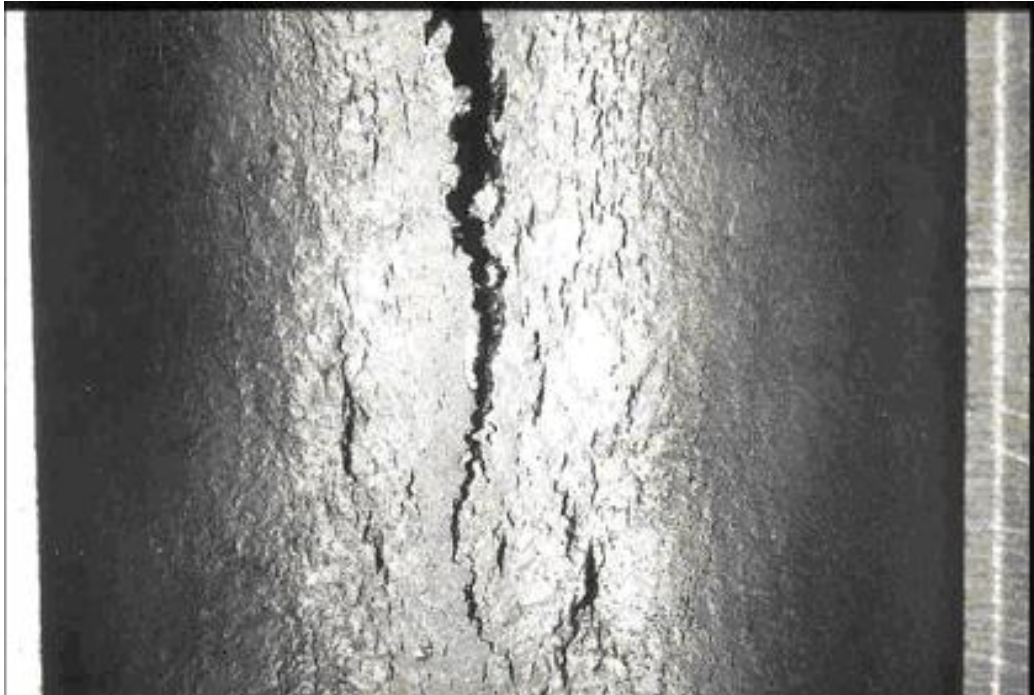
**Figure 4-18 – Creep rupture of an HK40 heater tube.**

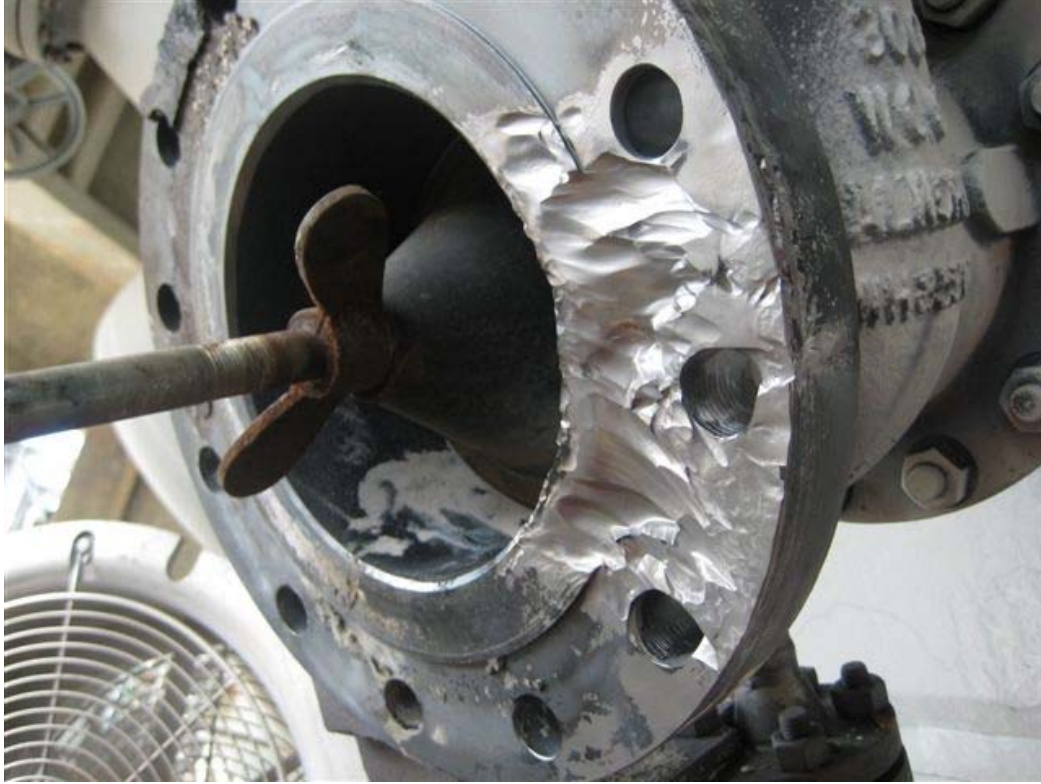
Figure 4-43 – Erosion Corrosion of a 1.25Cr 300 # valve flange on an FCC Catalyst withdrawal line.

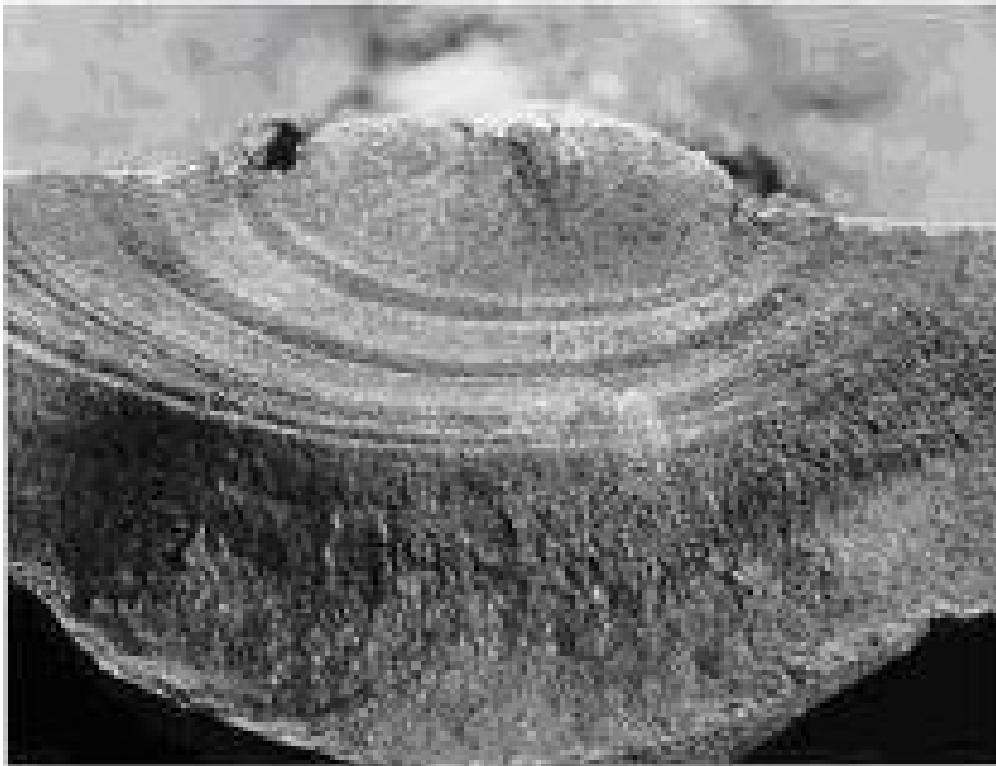
**Figure 4-53 – Fatigue fracture surface of a carbon steel pipe.**

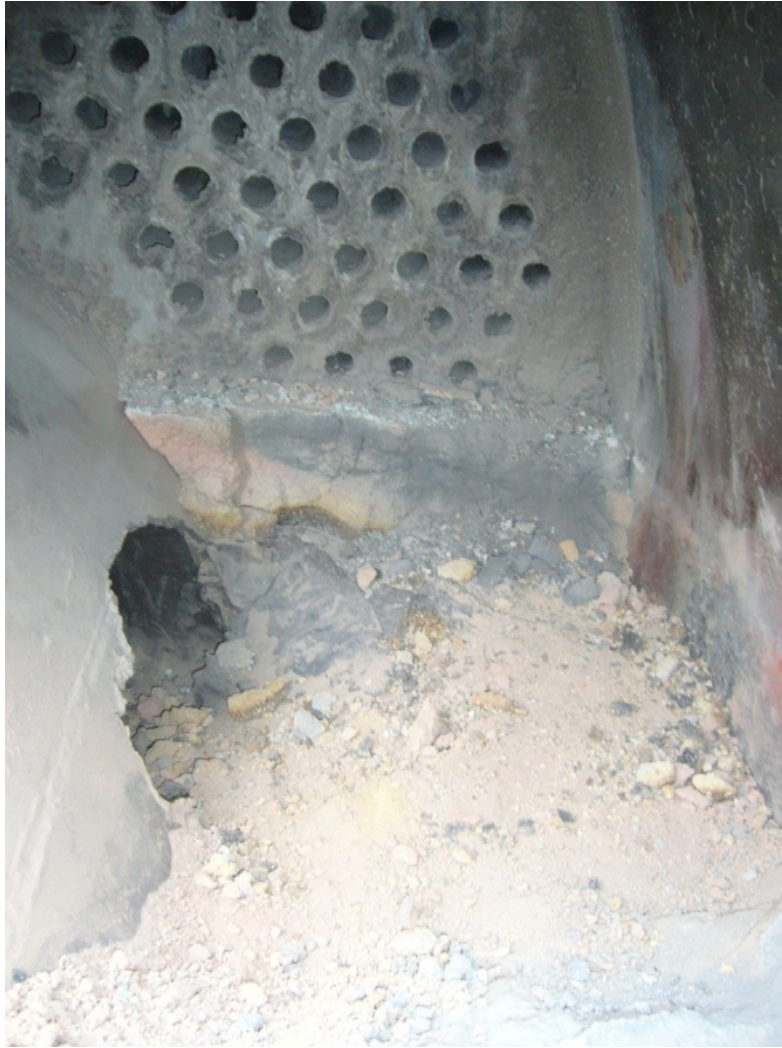
**Figure 4-66 – Same as figure above when viewed from a different angle.**

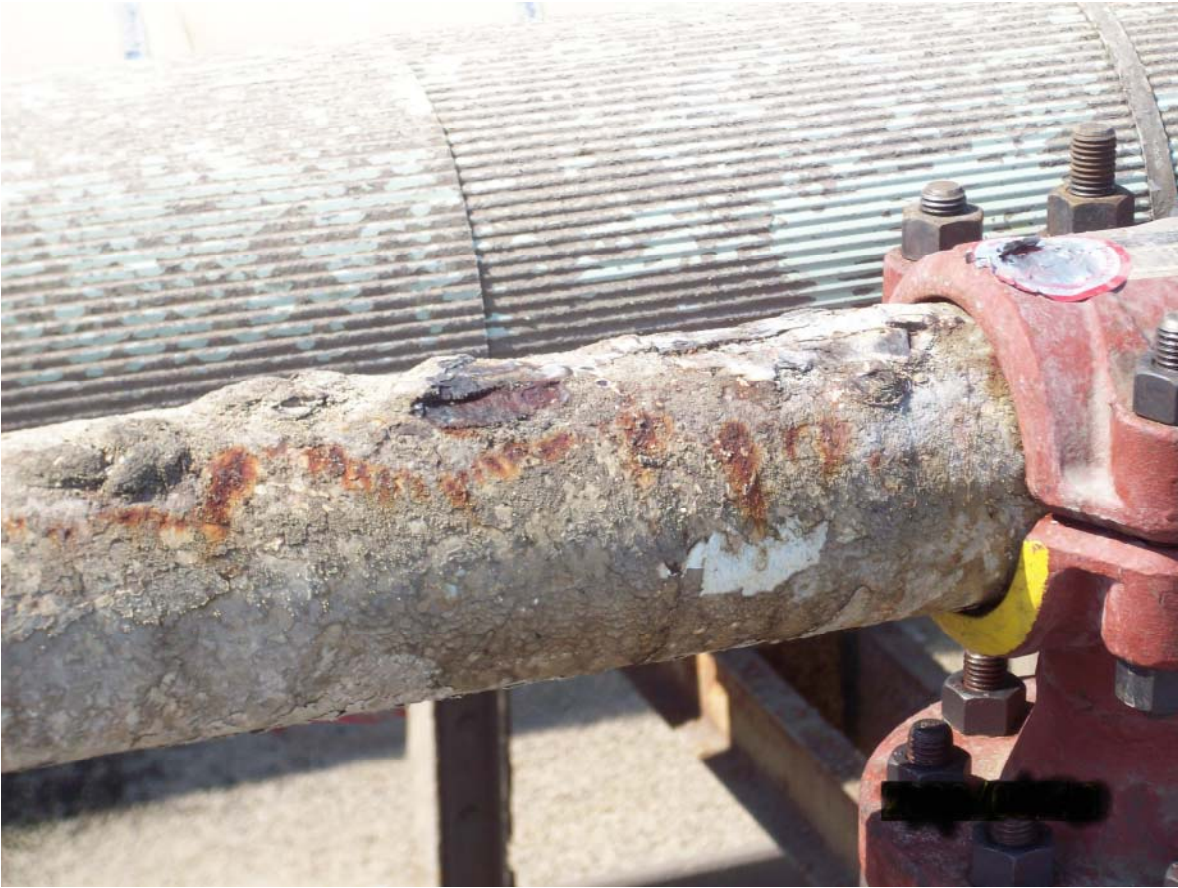
**Figure 4-72 – Atmospheric Corrosion of an LPG line in close proximity to a cooling tower.**

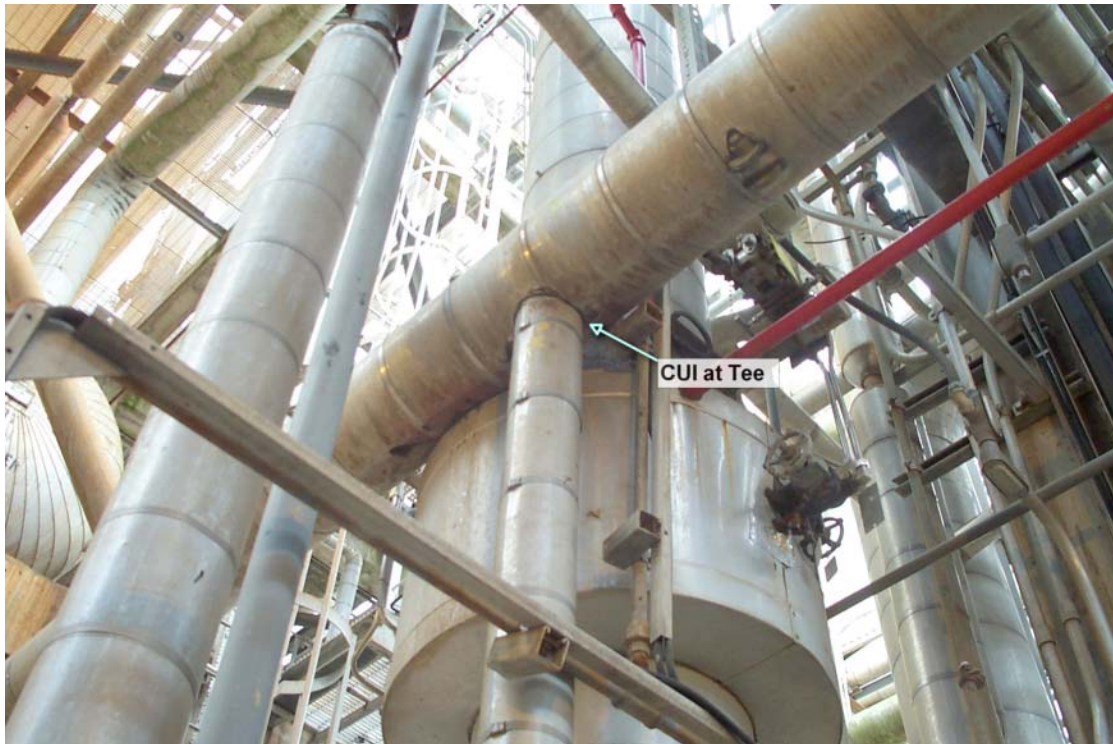
**Figure 4-73 – Tee in a 1000 psig ethylene line before insulation removal.**

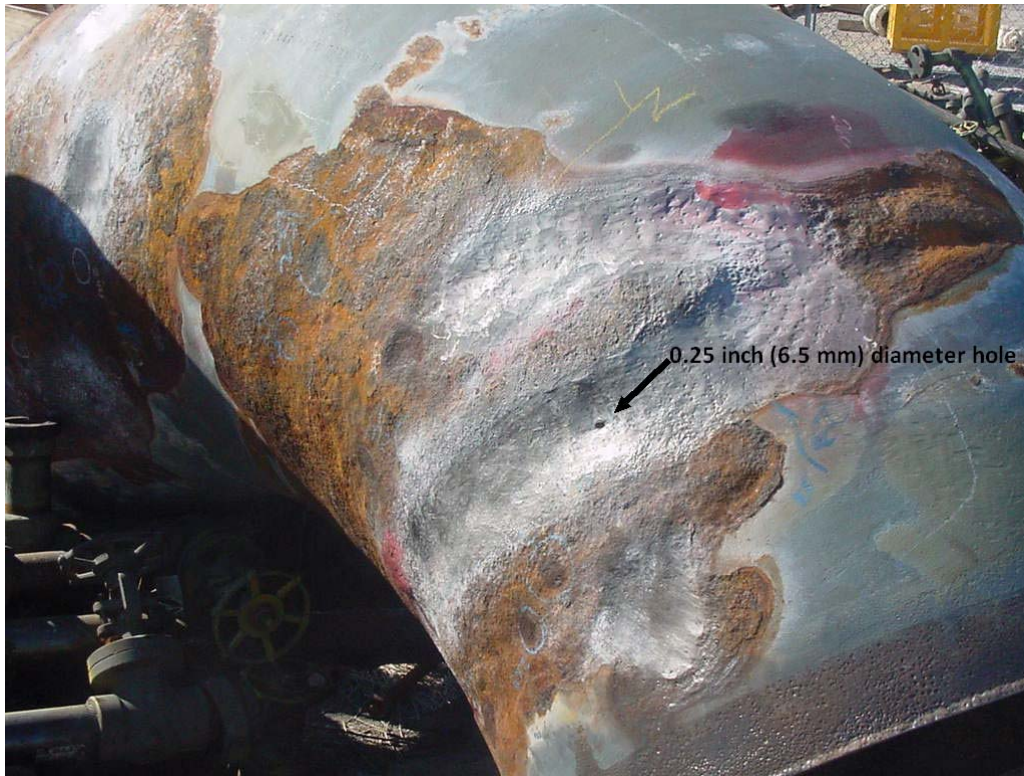
**Figure 4-75 – CUI of a 30 inch CS Butadiene line showing highly localized corrosion which could only be found by stripping the entire line. Note the 0.25 in (6.5 mm) diameter hole at arrow.**

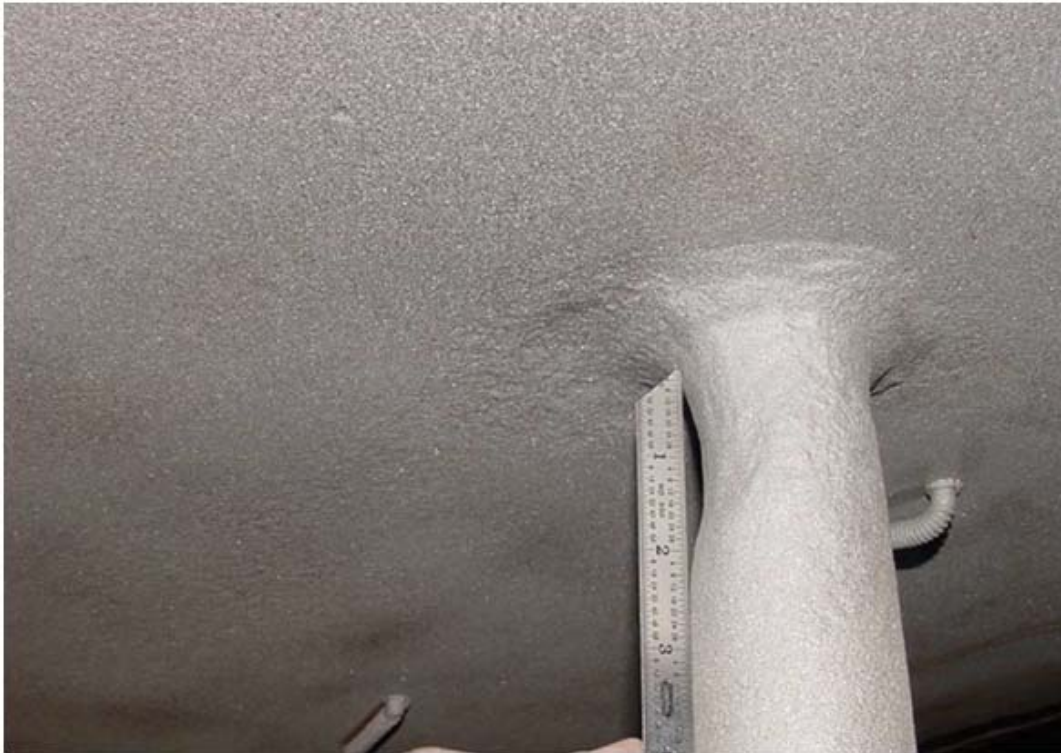
**Figure 4-76 – CUI of nozzle on a bottom head.**

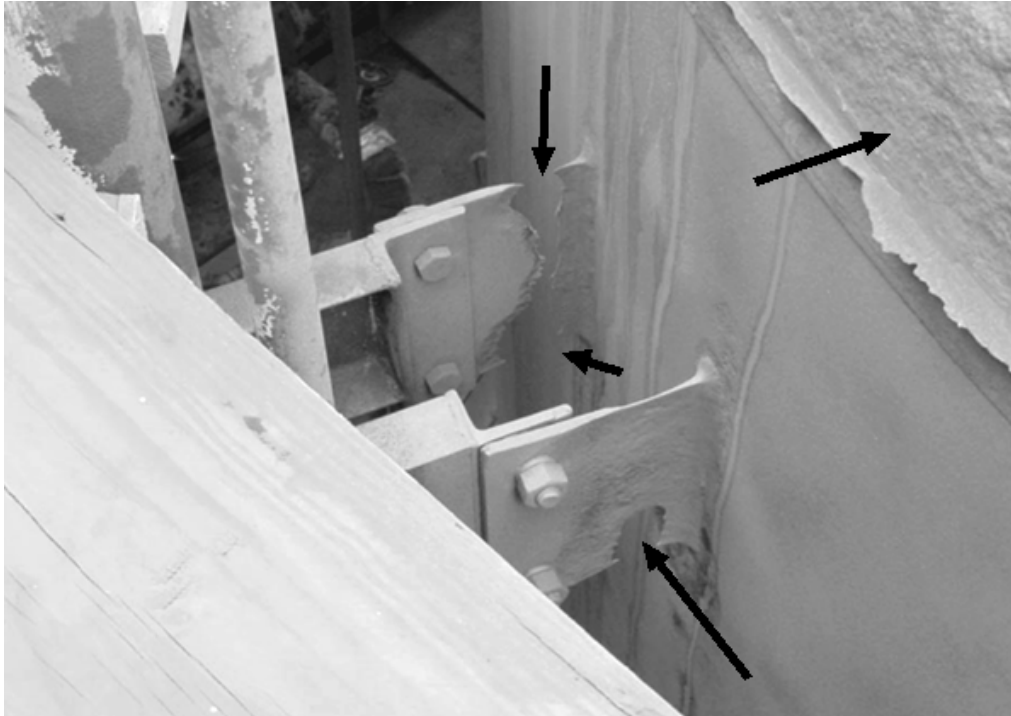
**Figure 4-79 – CUI at attachment supports and vessel head.**

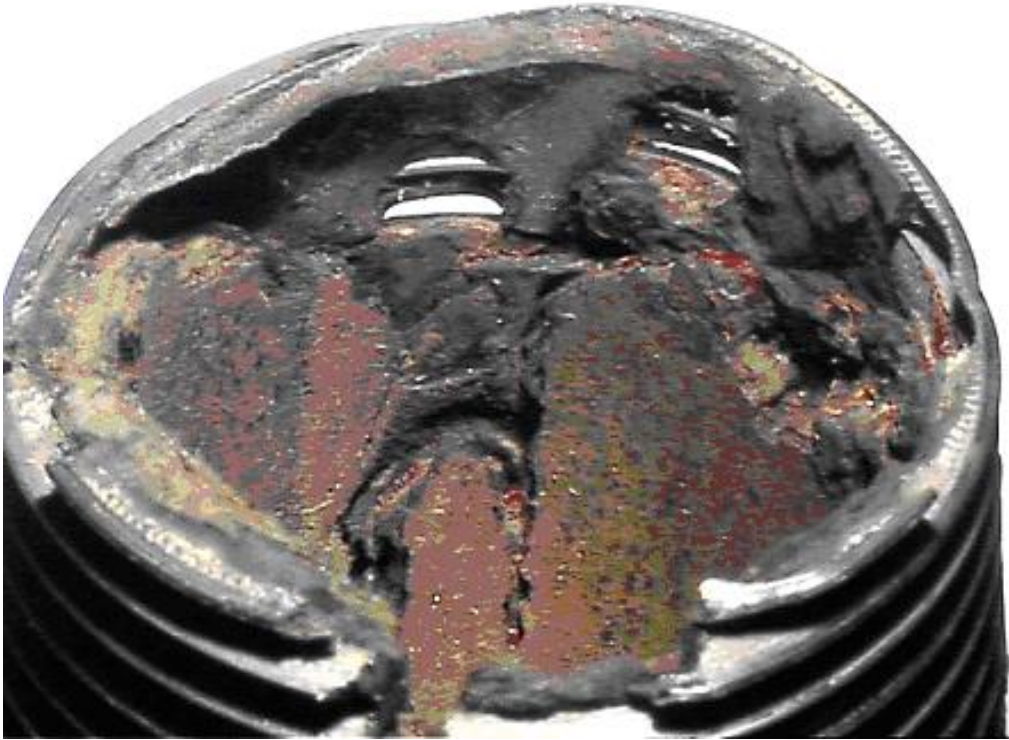
Figure 4-87 – CO<sub>2</sub> corrosion of CS pipe nipple in CO<sub>2</sub> contaminated water.

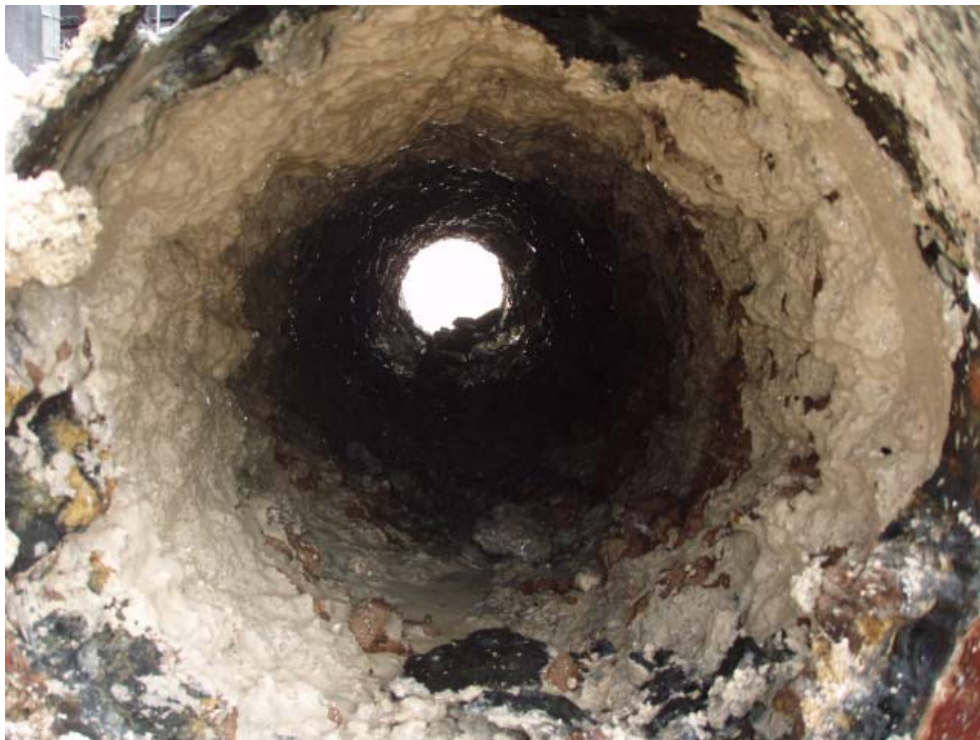
**Figure 4-106 – View of concrete lining inside the failed line shown in Figure 105.**

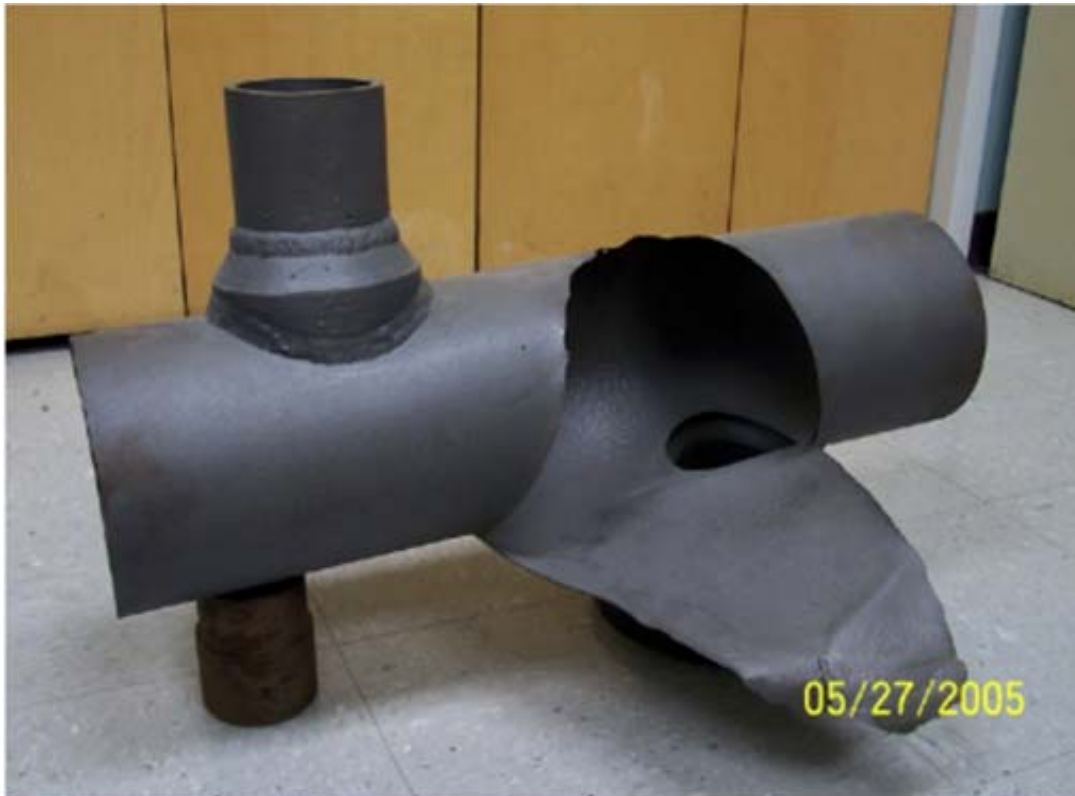
**Figure 4-116 – Sulfidation failure of NPS 8 carbon steel pipe. Note the relatively uniform thinning that resulted in a sizeable rupture.**

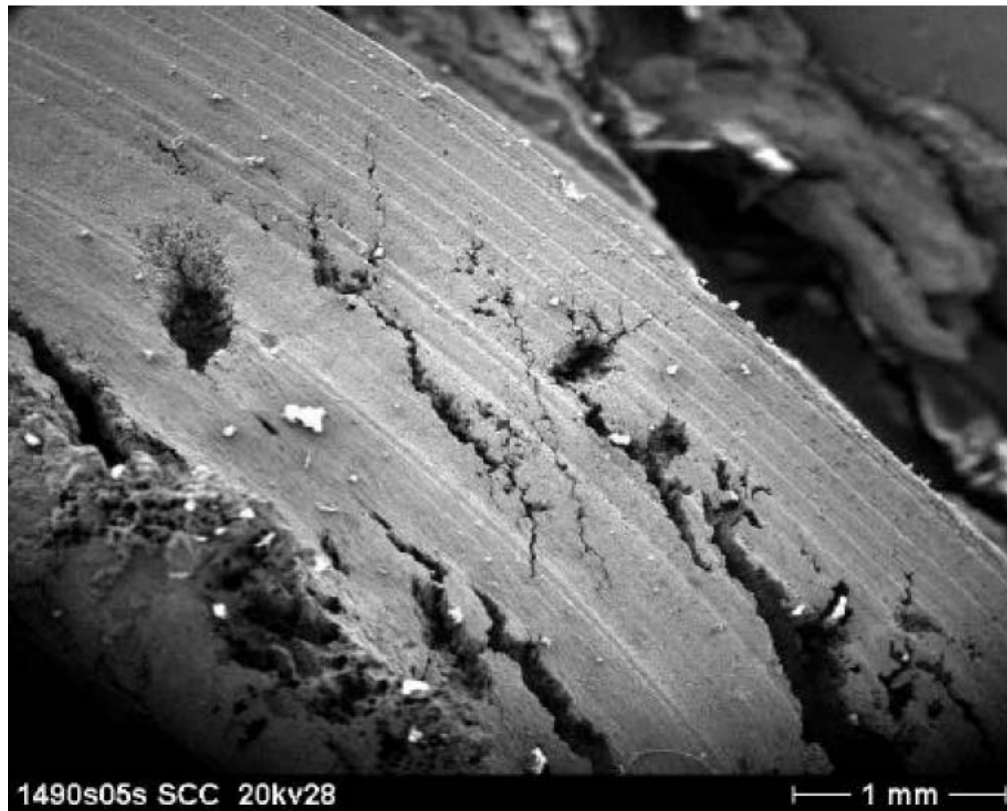
**Figure 4-139 – Chloride SCC on the thread surface of a failed 303SS bolt.**

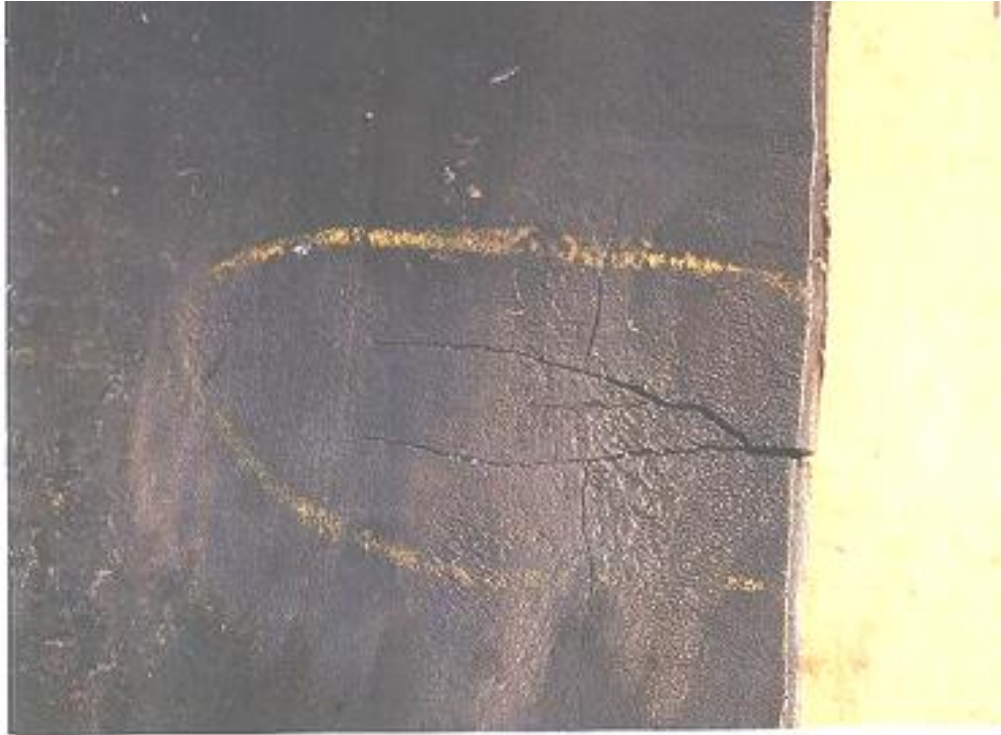
**Figure 4-159 – Liquid metal embrittlement of Monel caused by mercury in an FCC gas plant overhead drum.**

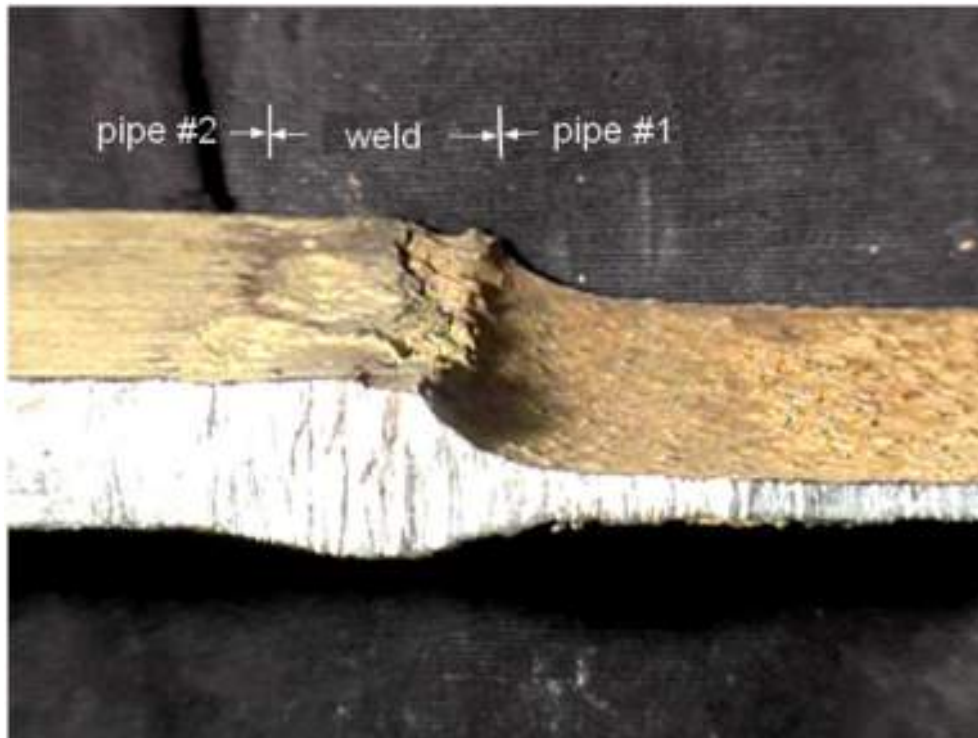
**Figure 5-12 – Cross-section of a carbon steel pipe showing preferential corrosion of the pipe with high residual element content on the right, as compared to the low residual pipe section to the left of the weld (Reference 3).**

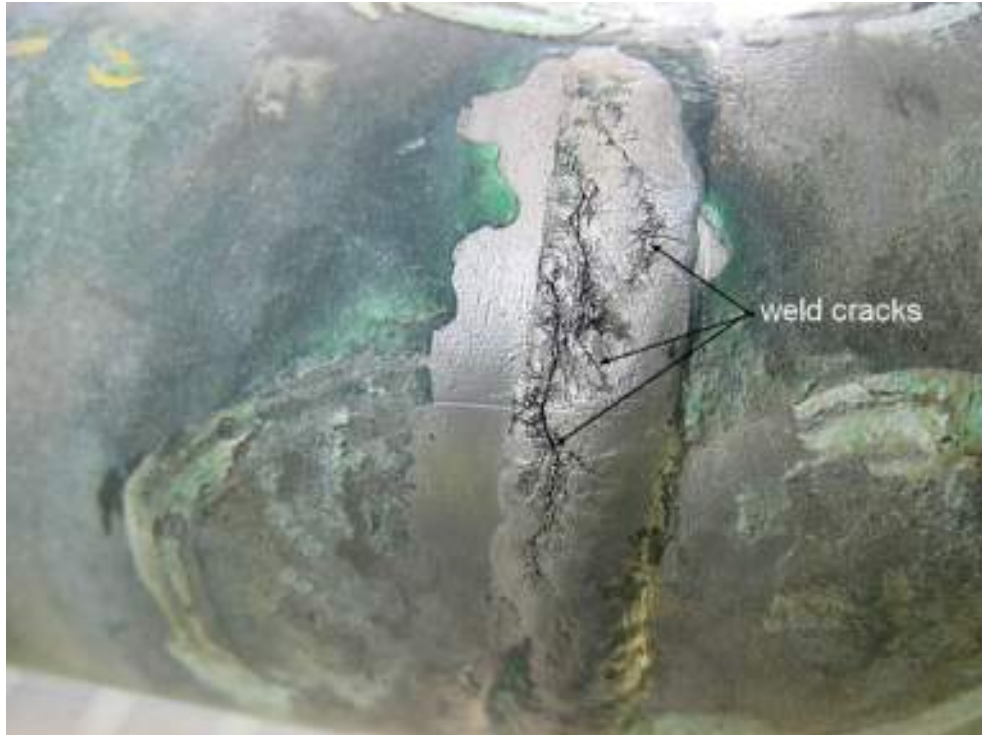
**Figure 5-16 – HF stress corrosion cracking of Alloy 400 vent line in an acid dump system (Reference 8).**

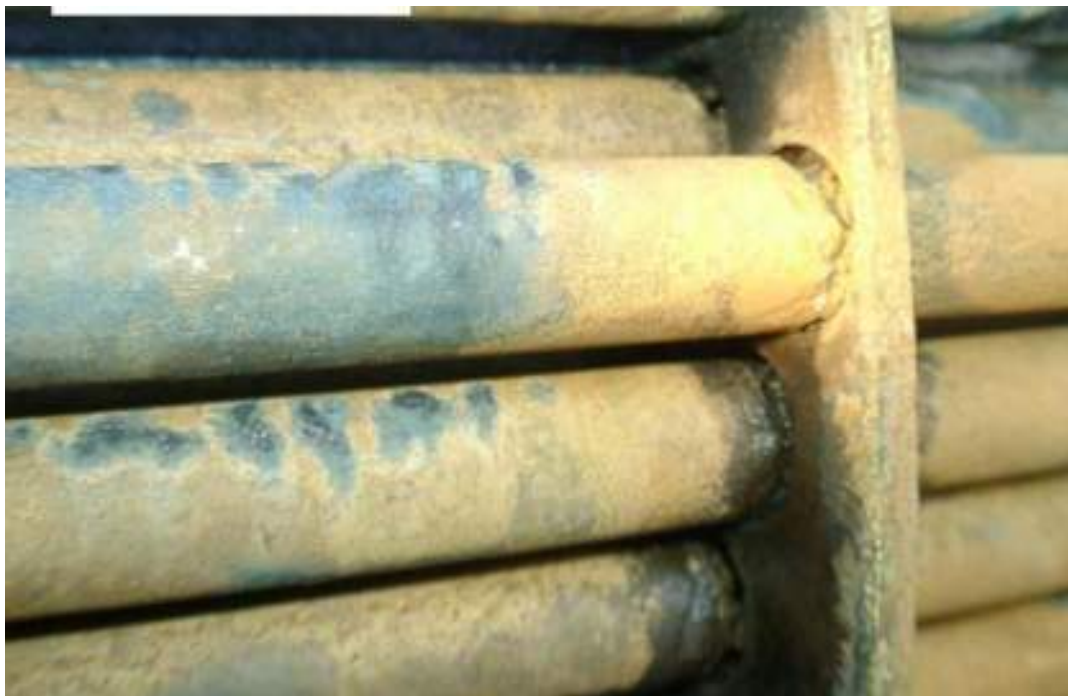
Figure 5-22 – Accelerated corrosion under a baffle.

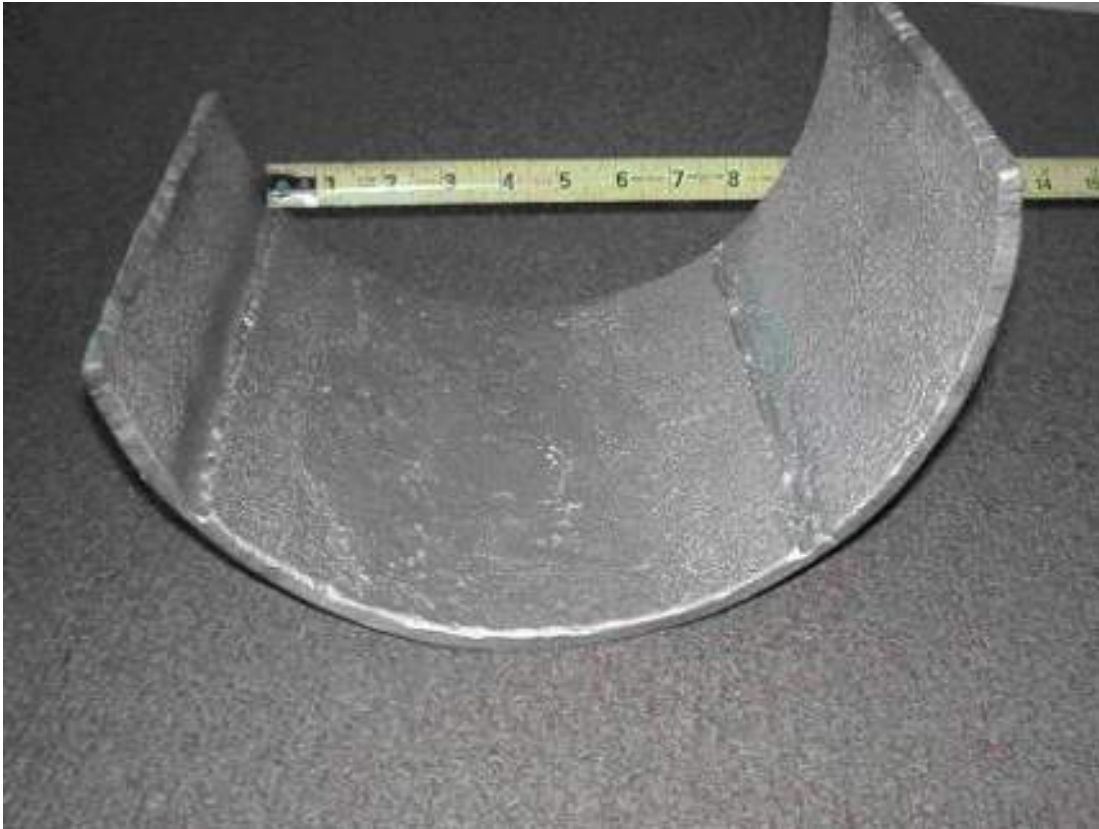
**Figure 5-23 – Grooving corrosion in the carbon steel vapor line from an alkaline water wash drum in a sulfuric acid alkylation unit.**

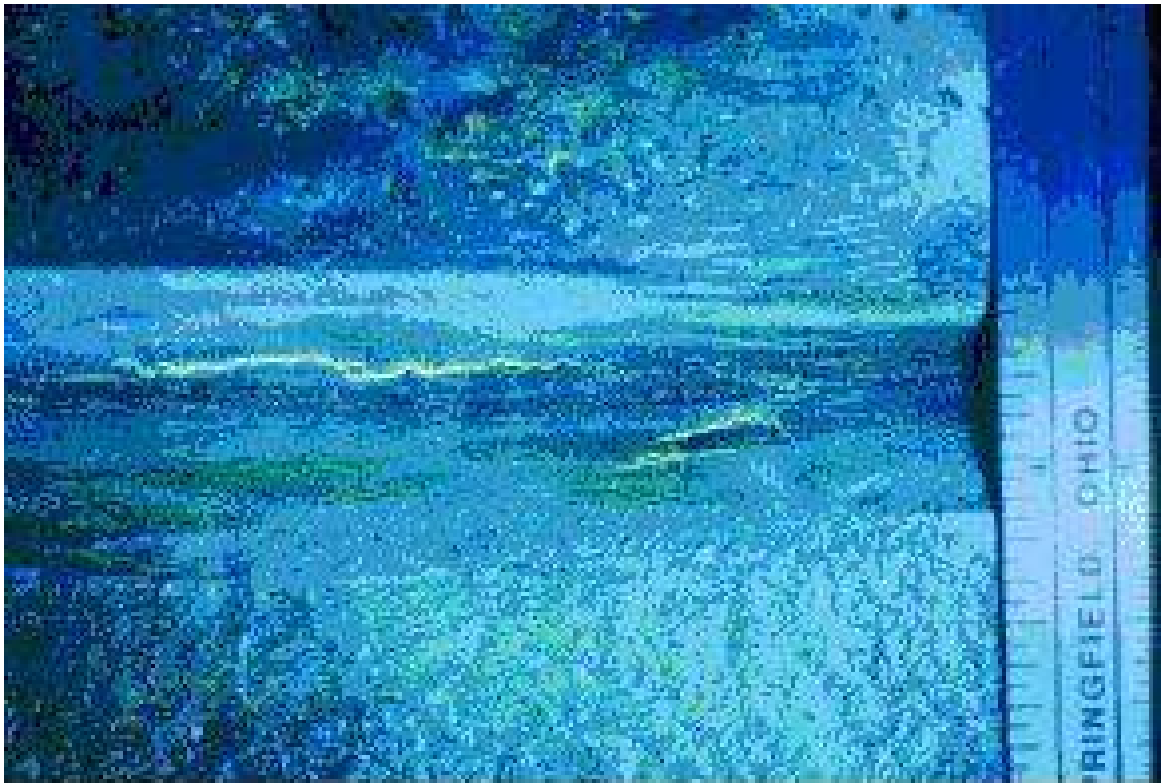
Figure 5-41 – Photograph showing WFMT of SOHIC damage.

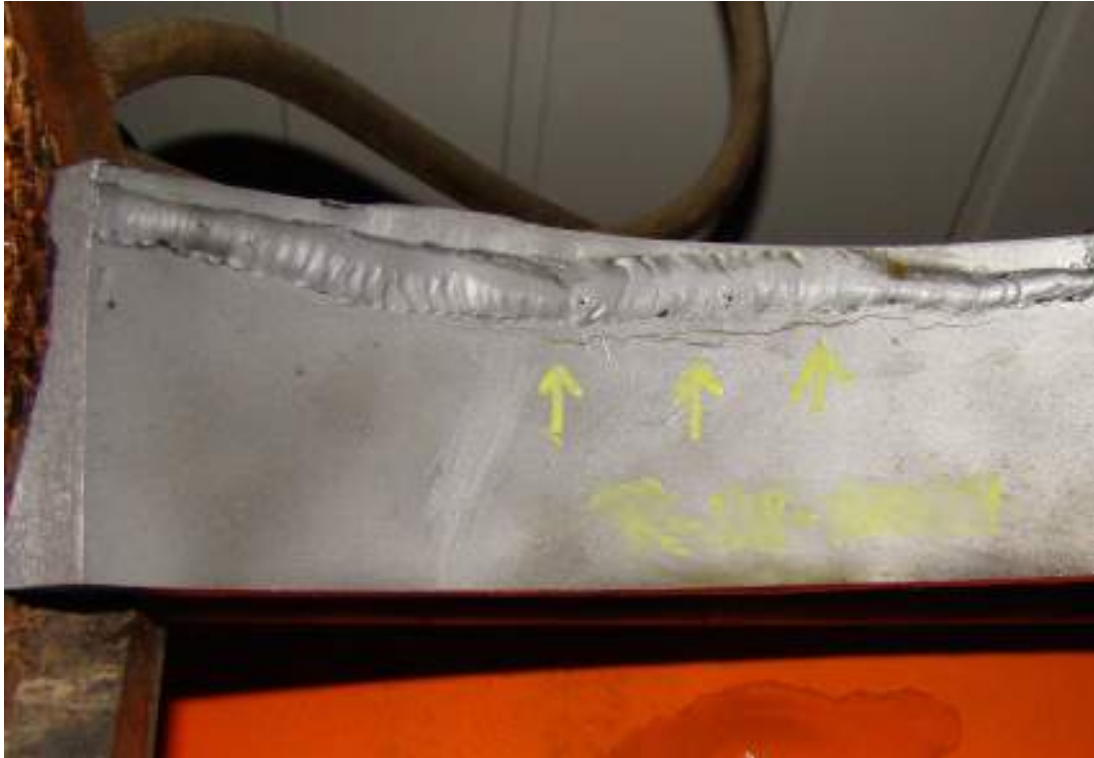
**Figure 5-46 – Overhead interstage knockout drum vapor outlet nozzle.**
